Manhole Inspection Summary

Manhole # S23II_007MH

Insp Date: **9/29/07 11:14 AM**

Location Address: **558 BAKER ST**

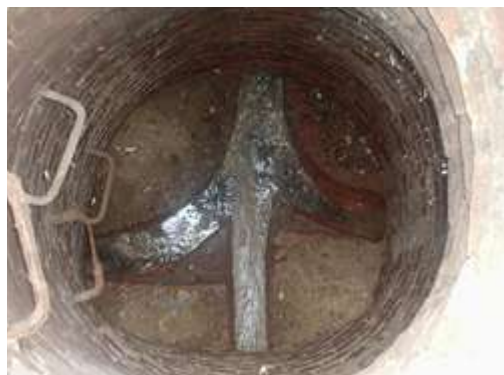
Top View

Corroded steps. Evidence of surcharge - Bench debris. Channel debris.

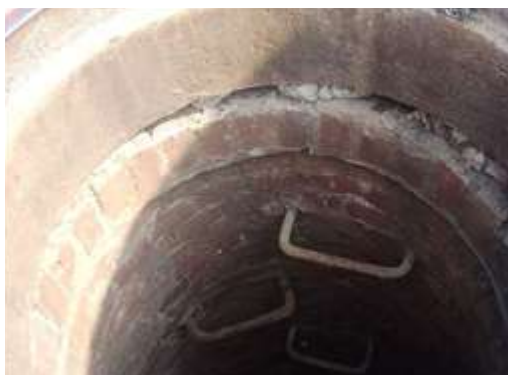
Defect

Frame leaks. Adjustment deterioration and infiltrations. Corbel and Barrel infiltration.

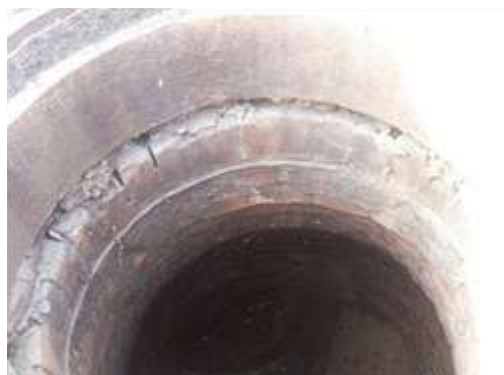
Defect

Frame leaks. Adjustment deterioration and infiltrations. Corbel and Barrel infiltration.

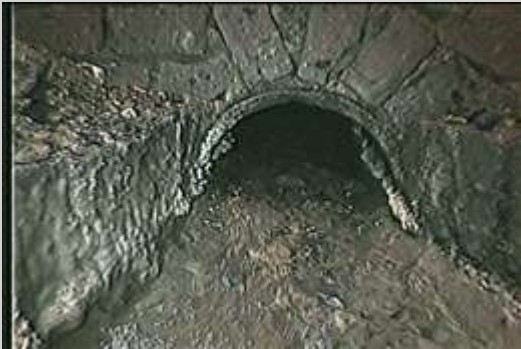
8 in. Circular Gravity Sewer Pipe Out @ 12 O'Clock

Deposits: ☐ None ☐ Mud ☐ Sludge ☐ Debris ☒ Grease

Infiltration: **Evidence** Pipe Seal Cond: **Unknown**

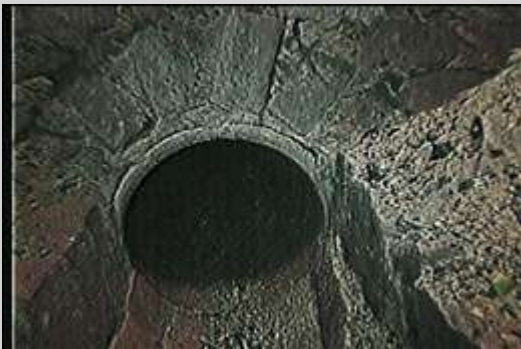
8 in. Circular Gravity Sewer Pipe In @ 3 O'Clock

Barrel deterioration and infiltration.

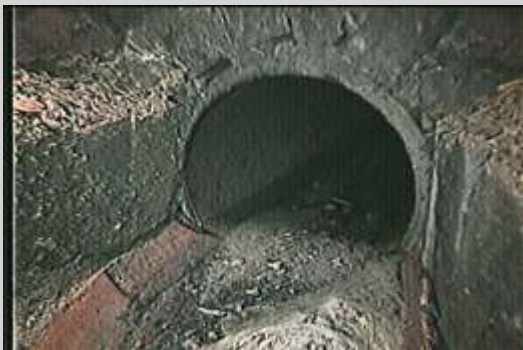
Pipe In @ 9 O'Clock

Channel deterioration.

Deposits: ☐ None ☒ **Mud** ☐ Sludge ☒ **Debris** ☐ Grease
